**Limited Asbestos Survey
For Recreational Center Building
Arthur Langford, Jr. Park**

**211 Thornton Street, SW
Atlanta, GA 30360**

Proposal No. 2013-0012

October 2013

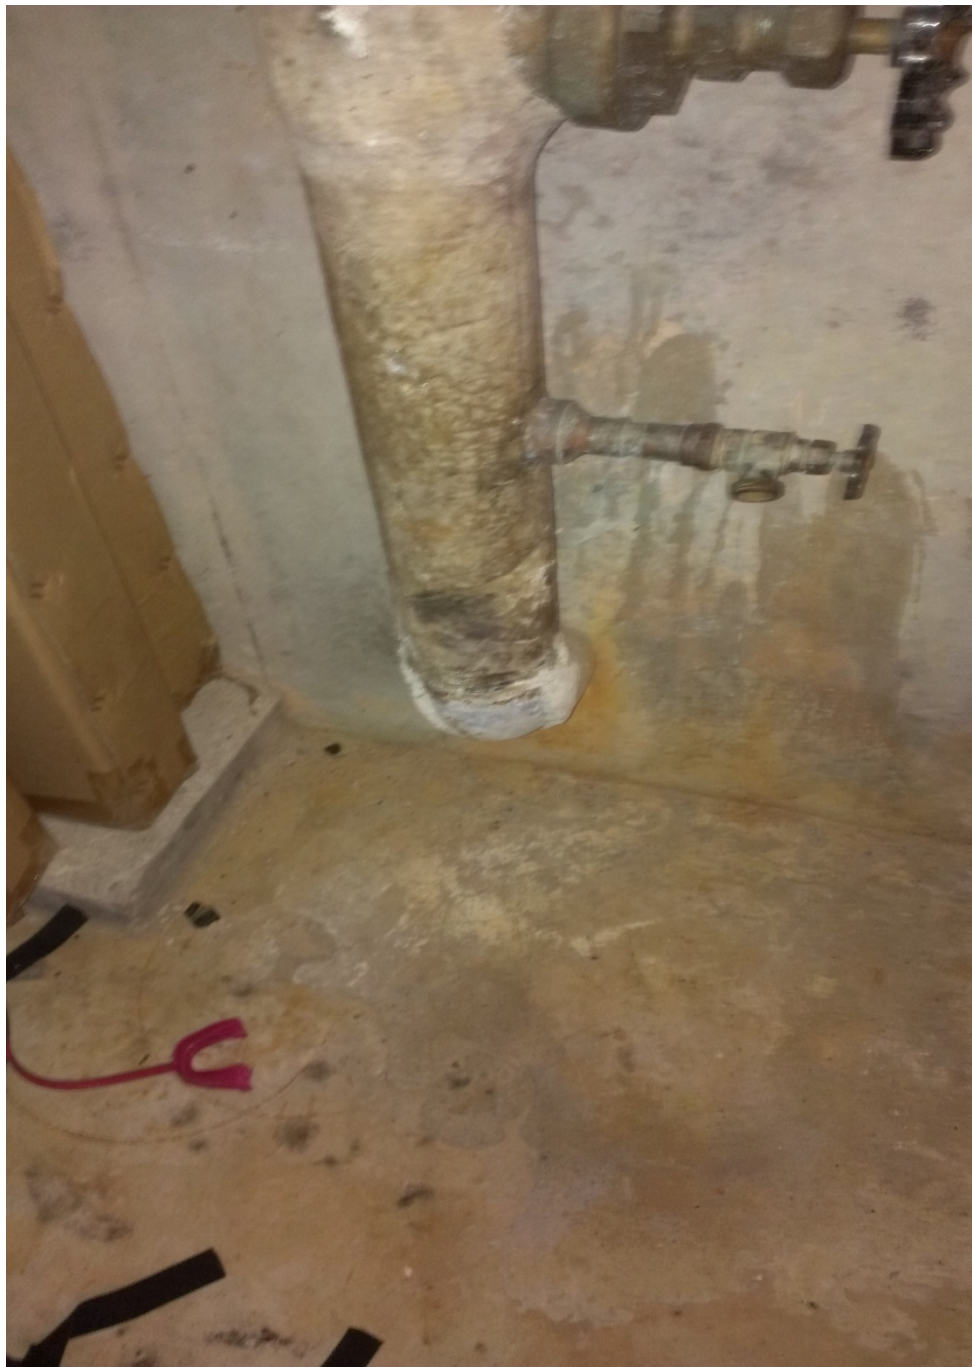
Asbestos in excess of the regulatory threshold was found in elbows and tees insulation on the cold water lines. The piping was observed throughout the basement and first floors of the recreational center building. The survey performed was not destructive, therefore, pipe runs inside wet walls and/or pipe chases were not accessible to the inspector to inspect, sample and quantify. Table 1 contains the suspect materials identified and sampled during the survey. The insulation on approximately 20% of the fittings was damaged and in some elbows and tees missing completely.

The elbow and tees insulation were classified as friable by the asbestos inspector. Therefore, the material could be crumbled and/or pulverized by hand pressure.

Mudded Elbow and Tee in Mechanical Room

The elbows and tees insulation should be removed prior to renovation to prevent disturbance. If this material is to stay in place it is suggested that the material be repaired immediately and signs posted to ensure that they are not damaged by unauthorized personnel. Access to the area should be limited to only authorized personnel. This material must be removed by a licensed Georgia asbestos abatement Contractor.

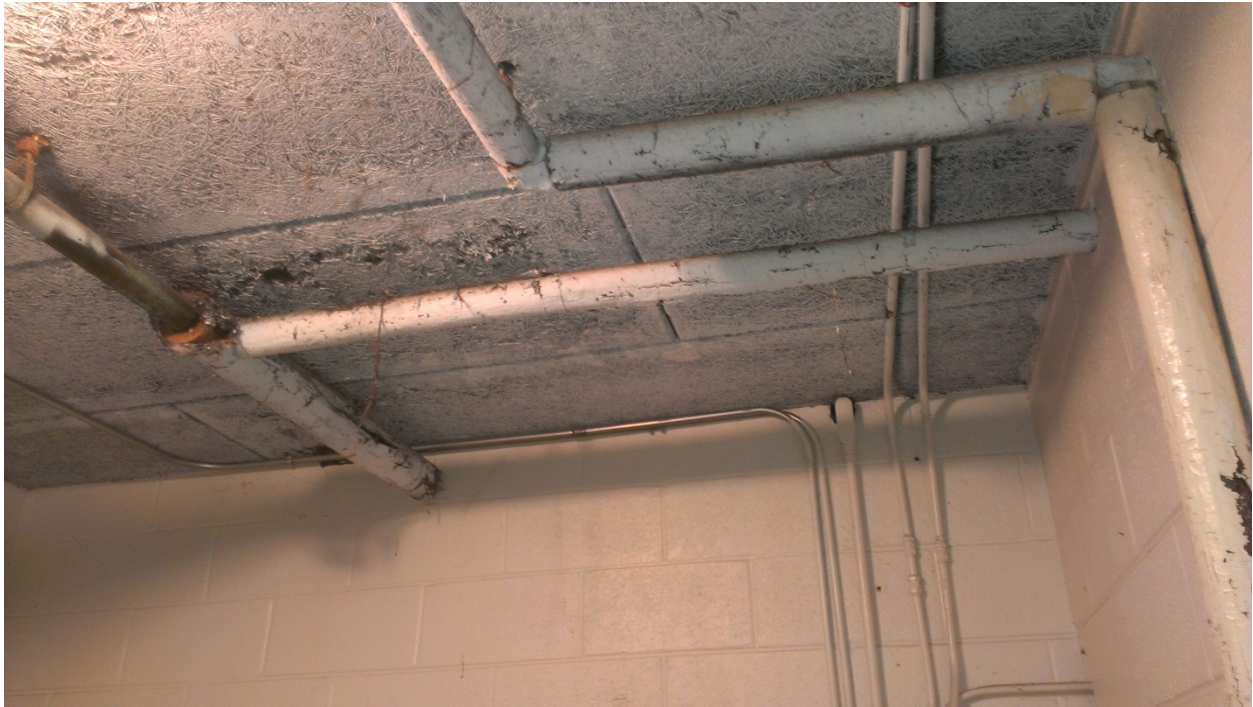
Damaged elbows have the potential for additional damage. The pipe runs are exposed below the tectum ceiling in basement. There is a potential for children and building occupants in the locker room areas to get exposed to airborne asbestos fibers.

Muddied Elbows and Tees in Boys Locker Room

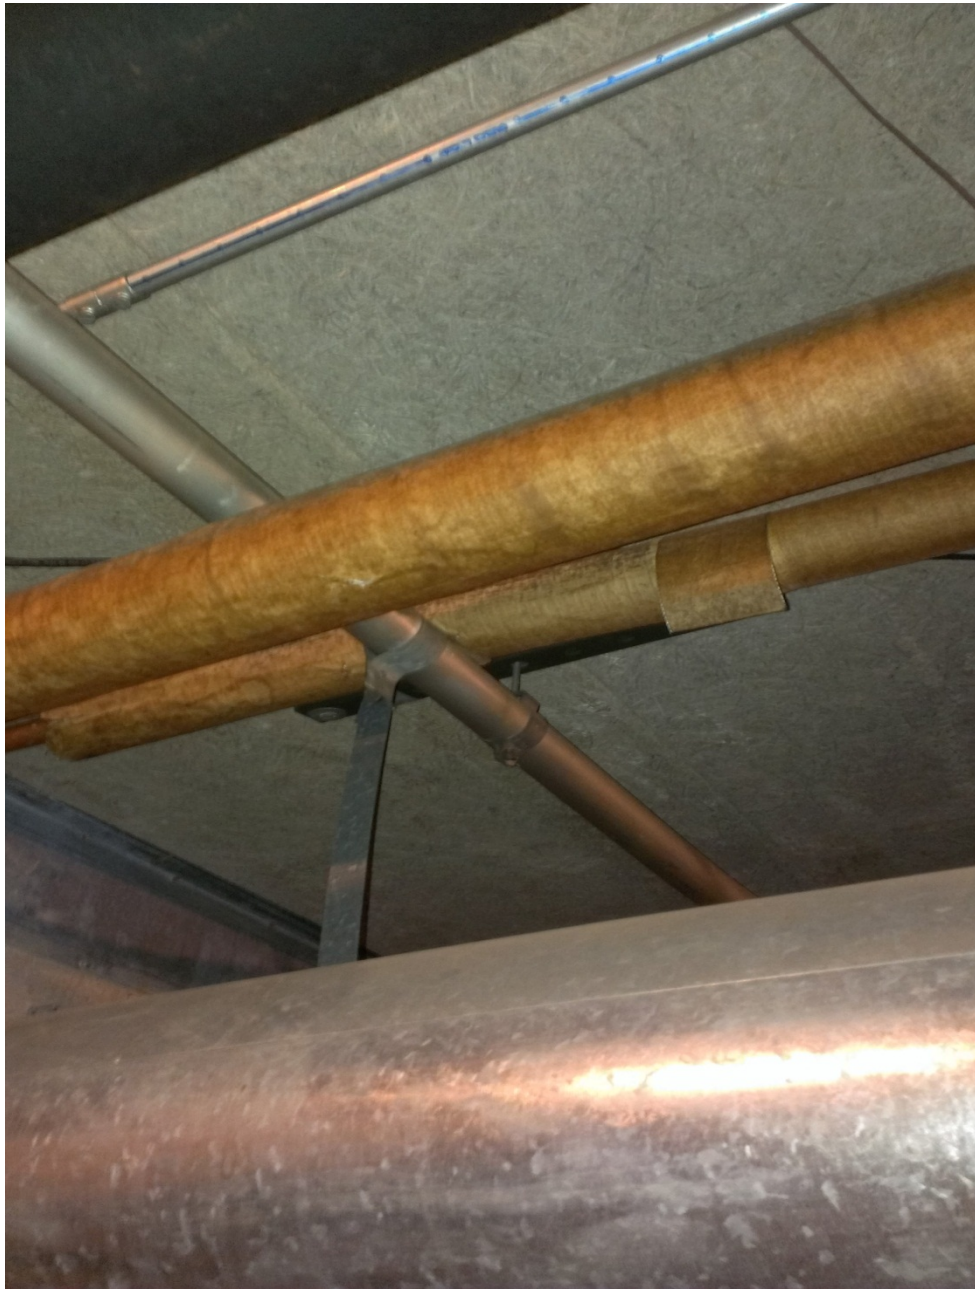
Pipes Run Through the Hall First Floor

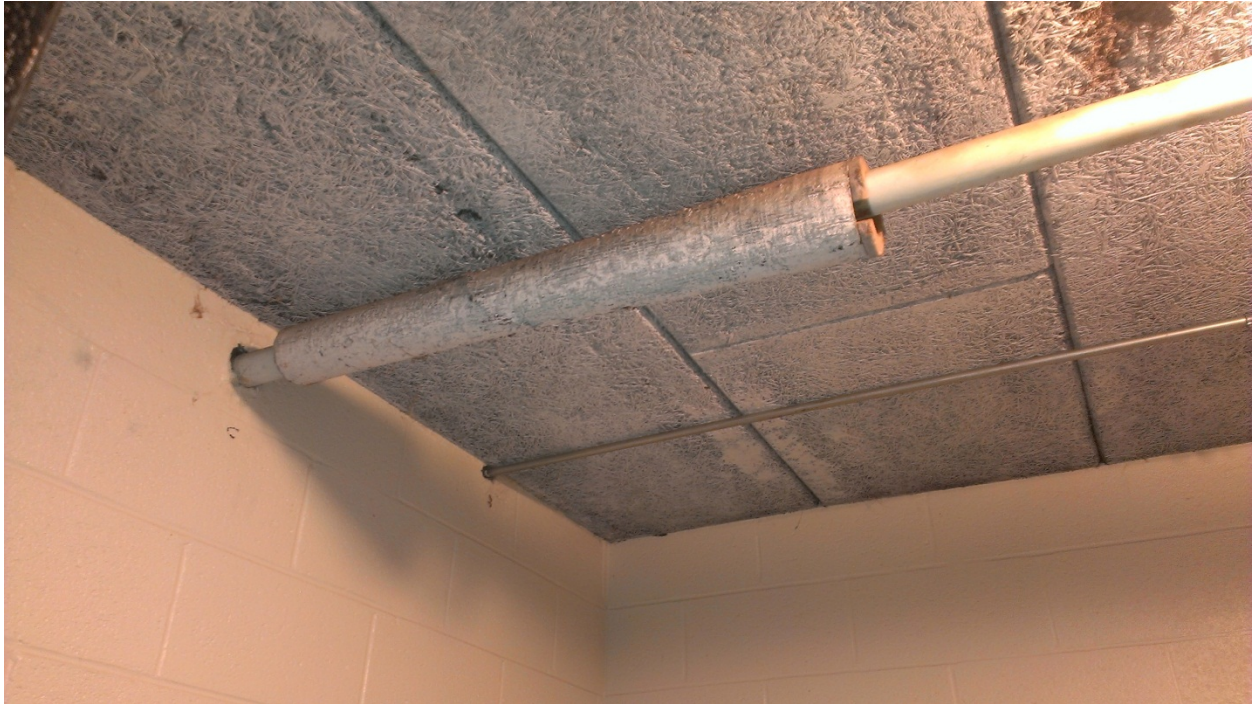
Pipe Insulation in Boys Locker Room
